Fiberoptic Sensor Experience in Oregon

Tim H. Thex, P.E.
Oregon Department of
Transportation
Transportation Systems
Monitoring Unit

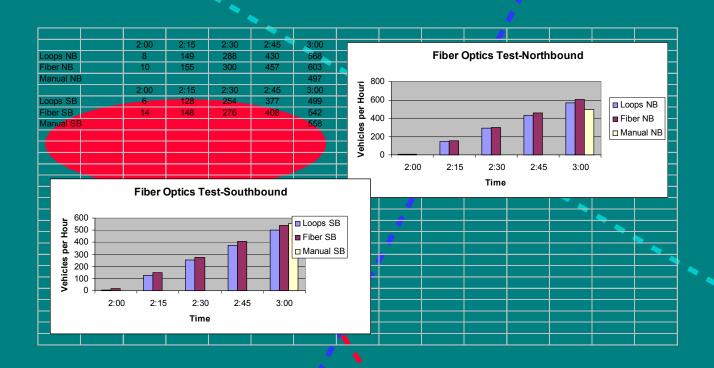
Preliminary Testing

- Accuracy still questionable according to first tests
- Depth of 3/16" subject to pavement wear and studded snow tires
- Oregon can see possibilities for better machine classification
- Fiberoptics can be adapted to existing equipment
